**Flood Control Project Maintenance
Levee Inspections**

Fall 2018 Levee Maintenance Deficiency Summary Report

Yolo County Service Area 6

Waterway			Bank	Unit Miles
Unit No. 01 Right Bank of Sacramento River at Knights Landing			Right	5.87
	Spring (March - May)	Summer (June - August)	(September - November) Fall	Winter (December - February)
Unit Maintenance Rating (Fall Only)			U	
Date of Inspection	3/15/2018 - 3/15/2018		9/28/2018 - 9/28/2018	
DWR Inspector	Zach Jojola		Zach Jojola	
Accompanied By	Casey Leibler Yolo County		Casey Leibler Yolo County	
	Elisa Sabatini Yolo County		Thomas Engler MBK	
	Thomas Engler MBK

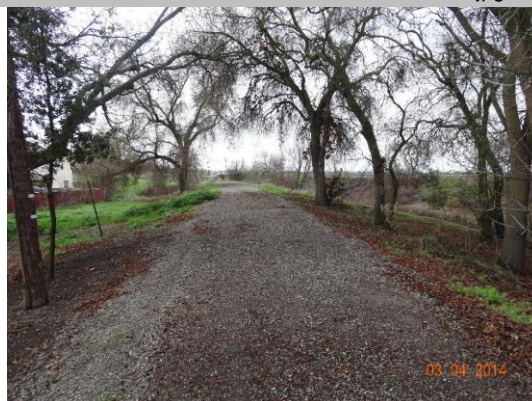
Photo 2 of 3 : UCIP_FA_2018_31903_58221.jpg

Overview of levee crown looking at crossing.

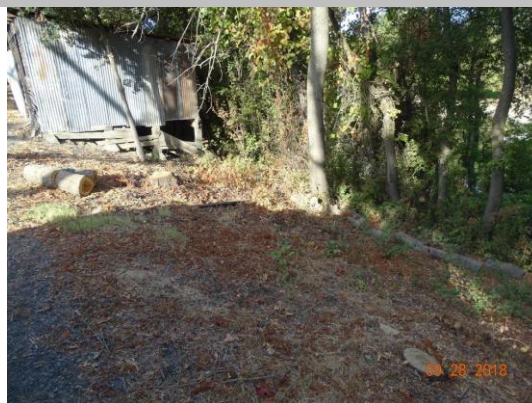
Photo 1 of 1 : FA_2018_NA0022_350_49_20181001_00129.jpg

LM Start	0.15	Rating **	M	Issue No.	49
LM End	0.15	Issue Type +	Ma	Location *	WS
Category	Earthen Levee			GPS Latitude/Longitude	
				Start	End
Item	Encroachments			38.800842°	38.800842°
				-121.722777°	-121.722777°
DWR ID	DWR_NA0022_01_f_2018_49				
Comment Code					
TR : Tree or limb					
Inspector Comment

View of the tree limbs on the waterside slope. Fall 2018.

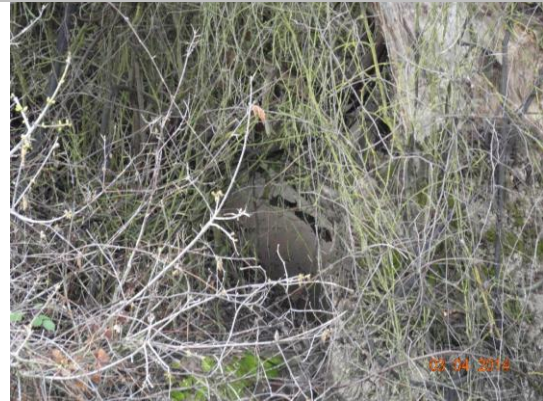
Photo 1 of 3 : UCIP_FA_2018_31904_58228.jpg

LM Start	0.21	Rating **	M	Issue No.	397
LM End	0.21	Issue Type +	En	Location *	
Category	Supplemental			GPS Latitude/Longitude	
				Start	End
Item	DWR UCIP Field Study			38.801280 °	38.801280 °
				-121.722000 °	-121.722000 °
DWR ID	19516				
Comment Code					
Inspector Comment					
FS_ID:31904 DS_ID:19516 EP_NO: N/A Repair Type: Non-Urgent Crossing Status: Indicator Found UCIP Comments: Need to properly abandon per Title 23 if corssing is no longer used--debris inside concrete box and near site. Need to contact owner. FIELD_STRUCT_DESC: 48-inch corrugated metal gravity drainage pipe through the levee, 14.5 feet below the crown. Slide gate in a concrete box on the waterside (WS) bank. (Automatic Board Order (ABO) issued as Permit No. Unknown, 1976 - Wallace) [Additional Reference(s): DWR Levee Log, 2005]. FS Date: 3/4/2014

Pipe section with holes abandoned on waterward side.

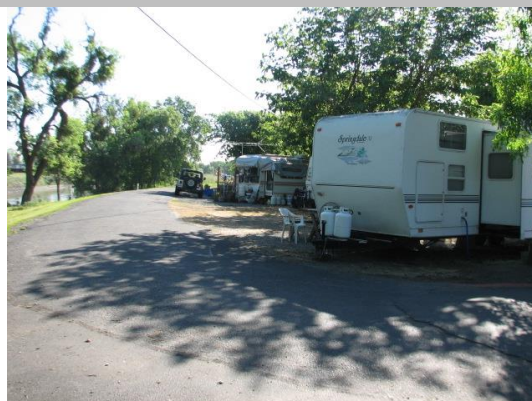
Photo 2 of 2 : FA_2018_NA0022_350_28_20180904_00016.jpg

LM Start	0.22	Rating **	M	Issue No.	28 (cont)	
LM End	0.25	Issue Type +	En	Location *	LS	
Category	Earthen Levee			GPS Latitude/Longitude		
				Start		End
Item	Encroachments			38.801394 °	38.801613 °	
				-121.721918 °	-121.721328 °	
DWR ID	DWR_NA0022_01_s_2012_28					
Comment Code						
BU : Building						
Inspector Comment						
RV park runs on and along levee to bridge.

Trailers on the crown of the levee. Spring 2014

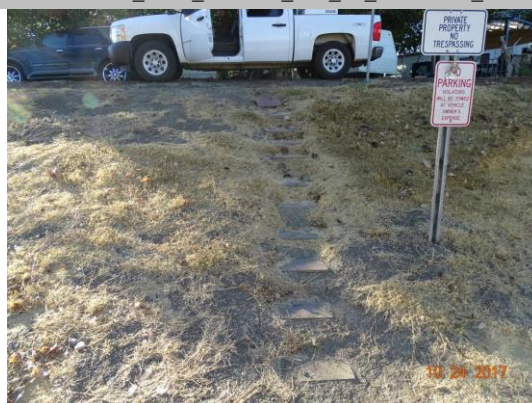
Photo 1 of 1 : FA_2018_NA0022_350_59_20180904_00029.jpg

LM Start	0.25	Rating **	M	Issue No.	59
LM End	0.25	Issue Type +	En	Location *	WS
Category	Earthen Levee			GPS Latitude/Longitude	
				Start	End
Item	Encroachments			38.801588 °	38.801588 °
				-121.721353 °	-121.721353 °
DWR ID	DWR_NA0022_01_f_2017_59				
Comment Code					
ST : Stairway					
Inspector Comment

View of stairs on landside slope. Fall 2017.

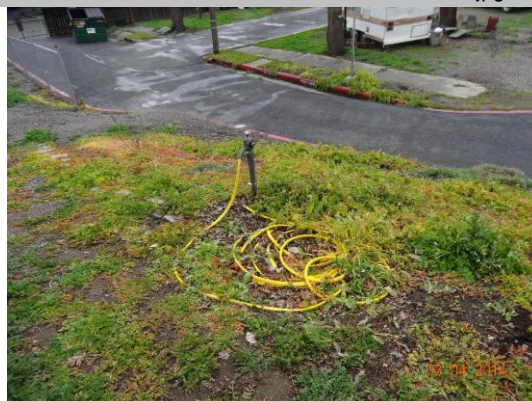
Photo 1 of 3 : UCIP_FA_2018_45403_60805.jpg

Comment Code						
Inspector Comment						
FS_ID:45403 DS_ID:19513 EP_NO: 9424 Repair Type: Non-Urgent Crossing Status: Indicator Found UCIP Comments: Unable to determine alignment of crossing--it's either through levee or along landward side. It appears that the waterline goes along landward side. Need to contact owner to obtain additional information about crossing. 2 inch metal pipe sticking out at the waterward berm edge. FIELD_STRUCT_DESC: Water pipe of an unknown size or material through the levee, at an unknown depth. Faucets on the landside (LS) slope. (Retention of an underground water pipe and faucet on the LS slope authorized under Automatic Board Order (ABO) issued as Permit No. 9424, 1974 - O. H. Ivey). [Additional Reference(s): DWR Levee Log, 2005]. FS Date: 3/4/2014

Spigot located on landward side.

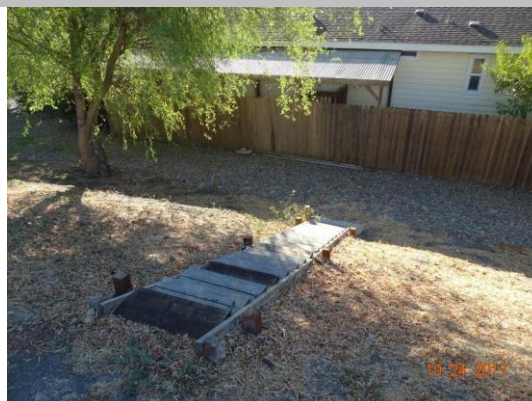
Photo 1 of 1 : FA_2018_NA0022_350_61_20180904_00030.jpg

LM Start	0.31	Rating **	M	Issue No.	61
LM End	0.31	Issue Type +	En	Location *	LS
Category	Earthen Levee			GPS Latitude/Longitude	
				Start	End
Item	Encroachments			38.801721°	38.801721°
				-121.720271°	-121.720271°
DWR ID	DWR_NA0022_01_f_2017_61				
Comment Code					
ST : Stairway					
Inspector Comment					
CVFPB enforcement item 2016-10754.

View of stairs on landside slope. Fall 2017.

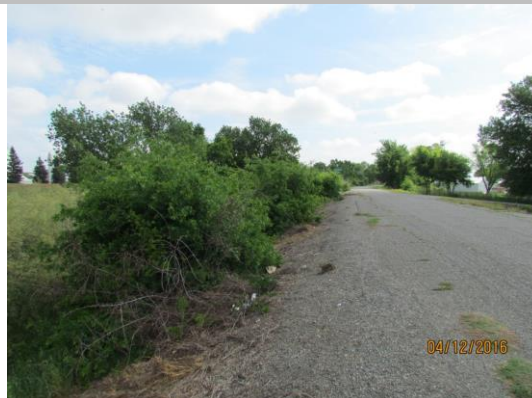
Photo 1 of 1 : FA_2018_NA0022_350_102_20180904_00051.jpg

LM Start	0.35	Rating **	M	Issue No.	102
LM End	0.48	Issue Type +	Ma	Location *	WS
Category	Earthen Levee			GPS Latitude/Longitude	
				Start	End
Item	Vegetation			38.801887°	38.802225°
				-121.719587°	-121.717186°
DWR ID	DWR_NA0022_01_s_2016_102				
Comment Code					
V2 : Remove the wild growth other than native grasses from the levee slopes.					
Inspector Comment					
Remove trees less than 4" in diameter at chest height.

View of the trees on the waterward side of the levee looking downstream. Spring 2016.

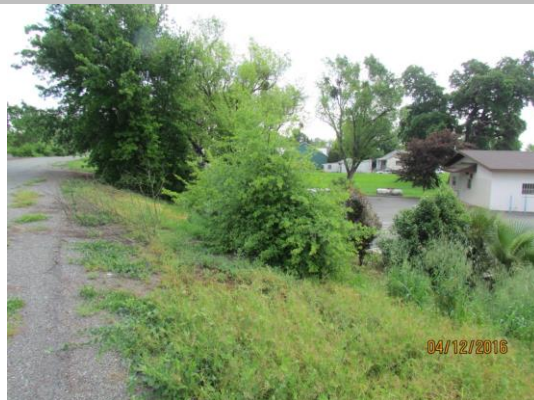
Photo 1 of 1 : FA_2018_NA0022_350_104_20180904_00052.jpg

LM Start	0.41	Rating **	M	Issue No.	104
LM End	0.43	Issue Type +	Ma	Location *	LS
Category	Earthen Levee			GPS Latitude/Longitude	
				Start	End
Item	Vegetation			38.802066 °	38.802126 °
				-121.718477 °	-121.718133 °
DWR ID	DWR_NA0022_01_s_2016_104				
Comment Code					
V2 : Remove the wild growth other than native grasses from the levee slopes.					
Inspector Comment

View of the tree on the landward side of the levee looking downstream.
Spring 2016.

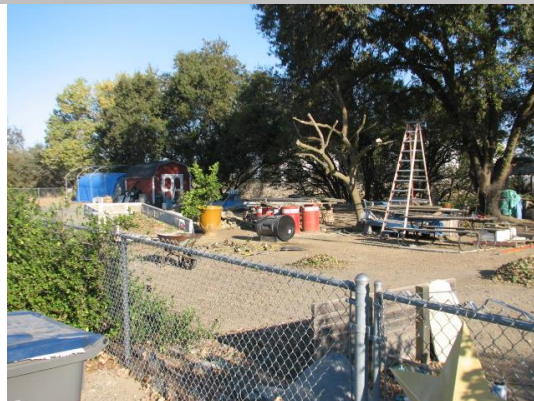
Photo 1 of 1 : FA_2018_NA0022_350_395_20180904_00063.jpg

LM Start	0.50	Rating **	M	Issue No.	395
LM End	0.54	Issue Type +	En	Location *	WS
Category	Earthen Levee			GPS Latitude/Longitude	
				Start	End
Item	Encroachments			38.802120°	38.801882°
				-121.716867°	-121.716165°
DWR ID	DWR_NA0022_01_f_2013_395				
Comment Code					
MA : Material					
Inspector Comment

Material blocking visibility on the waterside of the levee. Fall 2013

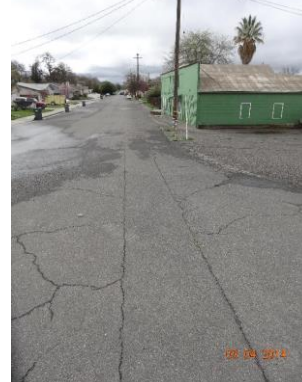
Photo 1 of 3 : UCIP_FA_2018_31627_57881.jpg

LM Start	0.51	Rating **	M	Issue No.	400
LM End	0.51	Issue Type +	En	Location *	
Category	Supplemental			GPS Latitude/Longitude	
				Start	End
Item	DWR UCIP Field Study			38.802062°	38.802062°
				-121.716740°	-121.716740°
DWR ID	19544				
Comment Code					
Inspector Comment					
FS_ID:31627 DS_ID:19544 EP_NO: N/A Repair Type: Non-Urgent Crossing Status: Indicator Found UCIP Comments: Unable to confirm if signs of crossing are for the same crossing listed here. Need to contact owner and determine additional information about crossing. Also found is service box for water line--need permit and alignment confirmation. FIELD_STRUCT_DESC: 10-inch steel pipe of an unknown purpose through the levee, at an unknown depth. [Additional Reference(s): DWR Levee Log, 2005. USACE Sacramento O&M Manual 127, June 1953, (Station 285+27)]. FS Date: 3/4/2014

View of landward side. Alignment is visible on paved road.

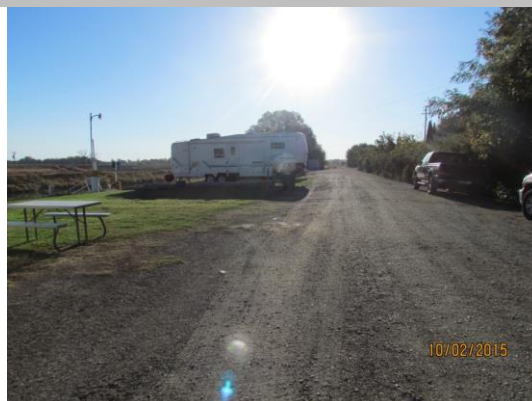
Photo 1 of 1 : FA_2018_NA0022_350_23_20180904_00012.jpg

LM Start	0.56	Rating **	A/W	Issue No.	23
LM End	0.64	Issue Type +	En	Location *	WS
Category	Earthen Levee			GPS Latitude/Longitude	
				Start	End
Item	Encroachments			38.801965°	38.801468°
				-121.715705°	-121.714348°
DWR ID	DWR_NA0022_01_s_2012_23				
Comment Code					
BU : Building					
Inspector Comment					
Yolo Sutter Yacht Club Permit No. 2778.

View of the Yacht club on the crown of the levee looking downstream.
Fall 2015.

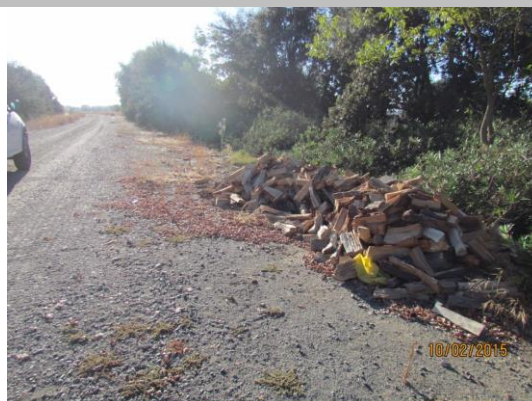
Photo 1 of 1 : FA_2018_NA0022_350_70_20180904_00033.jpg

LM Start	0.65	Rating **	M	Issue No.	70
LM End	0.65	Issue Type +	En	Location *	LS
Category	Earthen Levee			GPS Latitude/Longitude	
				Start	End
Item	Encroachments			38.801372 °	38.801372 °
				-121.714247 °	-121.714247 °
DWR ID	DWR_NA0022_01_f_2015_70				
Comment Code					
DE : Debris					
Inspector Comment

View of the firewood on the landward side of the levee looking downstream. Fall 2015.

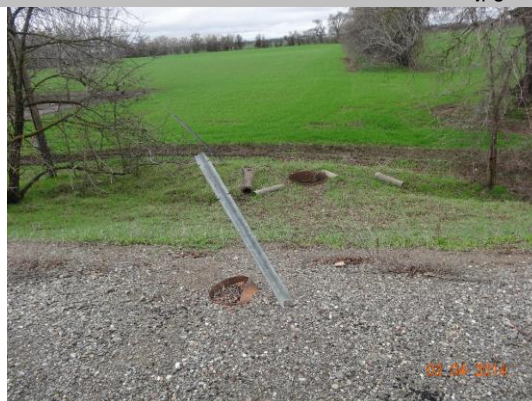
Photo 1 of 3 : UCIP_FA_2018_31912_58261.jpg

View of landward side.

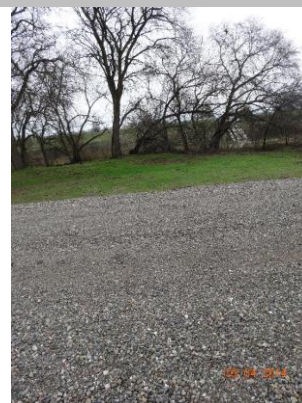
Photo 1 of 3 : UCIP_FA_2018_38190_69563.jpg

View of waterward side.

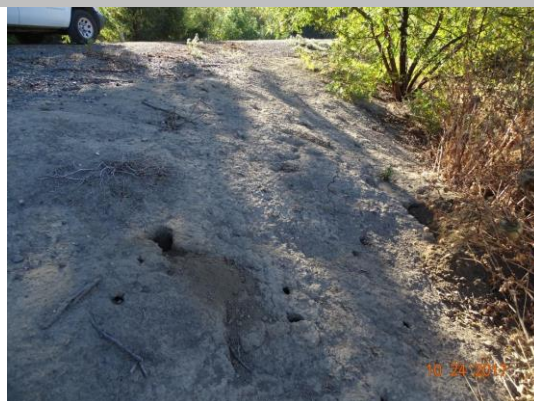
Photo 1 of 2 : FA_2018_NA0022_350_119_20180904_00056.jpg

LM Start	1.96	Rating **	M	Issue No.	119
LM End	1.96	Issue Type +	Ma	Location *	LS
Category	Earthen Levee			GPS Latitude/Longitude	
				Start	End
Item	Animal Control			38.795418 °	38.795418 °
				-121.695964 °	-121.695964 °
DWR ID	DWR_NA0022_01_s_2016_119				
Comment Code					
A3 : No rodents visible, but rodent burrows visible; need to backfill and compact or grout burrows.					
Inspector Comment					
Multiple rodent holes on landside slope near toe.

Updated view of rodent holes on landside slope. Fall 2017.

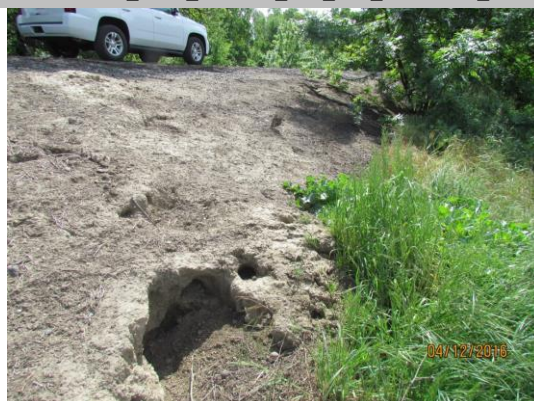
Photo 2 of 2 : FA_2018_NA0022_350_119_20180904_00057.jpg

View of the rodent hole on the landward side of the levee. Spring 2016.

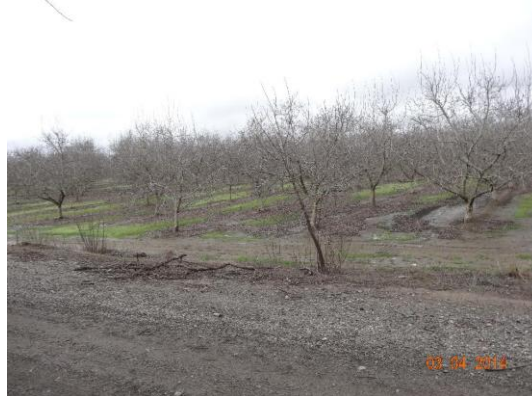
Photo 1 of 3 : UCIP_FA_2018_40536_58265.jpg

Comment Code						
Inspector Comment						
FS_ID:40536 DS_ID:19524 EP_NO: 9413 Repair Type: Non-Urgent Crossing Status: Found UCIP Comments: Alignment through levee unknown--no signs of crossing through landward side. Need to contact owner to determine status of crossing. This crossing appears to have been updated since 1970s. FIELD_STRUCT_DESC: 24-inch pipe of an unknown material or purpose through the levee, 15.5 feet below the crown. Gate valve on the landside (LS) end. Ramp on the waterside (WS) slope. (Retention of a 30-inch pipe through the levee and a slide gate in a corrugated metal pipe [CMP] riser on both slopes authorized under Automatic Board Order (ABO) issued as Permit No. 9413, 1974 - Wallace Construction Company). Added appurtenances noticed in 2014: pump, metal frame platform, flow meter, and control panel on the WS. Appurtenances could be associated with Permit No. 12804. This appears to be the same entry as DS_ID 19538. [Additional Reference(s): DWR Levee Log, 2005]. FS Date: 3/4/2014

View of landward side.

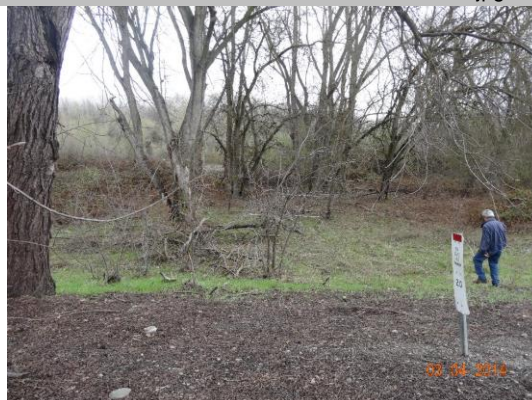
Photo 3 of 3 : UCIP_FA_2018_40536_58263.jpg

View of waterward side.

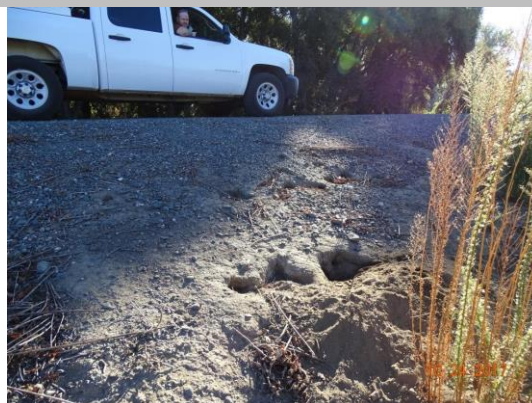
Photo 1 of 2 : FA_2018_NA0022_350_117_20180904_00054.jpg

LM Start	1.97	Rating **	M	Issue No.	117
LM End	2.06	Issue Type +	Ma	Location *	LS
Category	Earthen Levee			GPS Latitude/Longitude	
				Start	End
Item	Animal Control			38.795234 °	38.793974 °
				-121.695898 °	-121.695852 °
DWR ID	DWR_NA0022_01_s_2016_117				
Comment Code					
A3 : No rodents visible, but rodent burrows visible; need to backfill and compact or grout burrows.					
Inspector Comment

View of rodent holes on landside slope. Fall 2017.

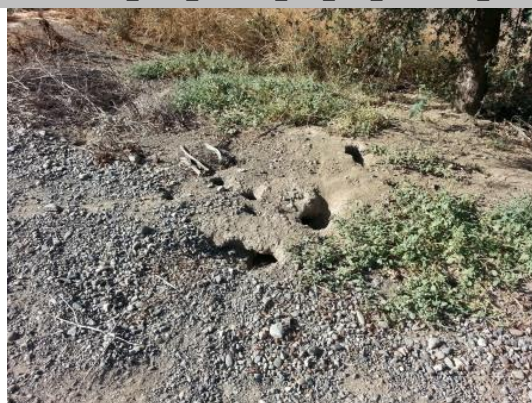
Photo 2 of 2 : FA_2018_NA0022_350_117_20180904_00055.jpg

Series of animal burrows on LS slope of the levee. Fall inspection 10/07/2016.

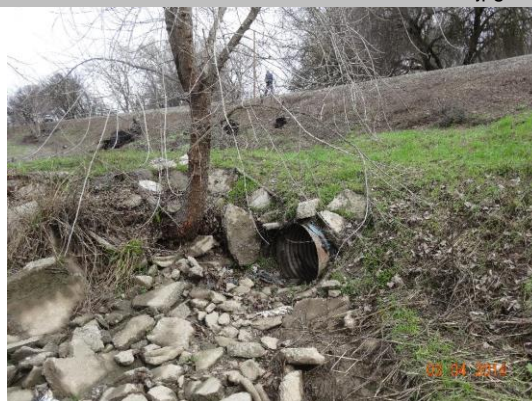
Photo 1 of 3 : UCIP_FA_2018_31632_57905.jpg

Outlet located on landward toe.

Comment Code						
Inspector Comment						
FS_ID:31632 DS_ID:19523 EP_NO: 9413 Repair Type: Non-Urgent Crossing Status: Indicator Found UCIP Comments: Erosion at outlet. Unable to determine if crossing is still in use. Will need to contact owner to determine status of crossing. FIELD_STRUCT_DESC: 30-inch corrugated metal gravity irrigation pipe through the levee, 13.5 feet below the crown. Slide gate on each end in a 48-inch corrugated metal pipe (CMP) riser. (Retention of a 30-inch pipe through the levee and a slide gate in a corrugated metal pipe [CMP] riser on both slopes authorized under Automatic Board Order (ABO) issued as Permit No. 9413, 1974 - Wallace Construction Company. Plans to relocate an existing incline irrigation pumping plant authorized under Permit No. 12804, 1979 - Wallace Construction Company). Pumping plant appears to be located at CLM 1.969, and pipe runs along the waterside (WS) berm and discharges into a ditch where the 30-inch pipe is used to convey the irrigation water to the landside (LS). [Additional Reference(s): DWR Levee Log, 2005]. FS Date: 3/4/2014

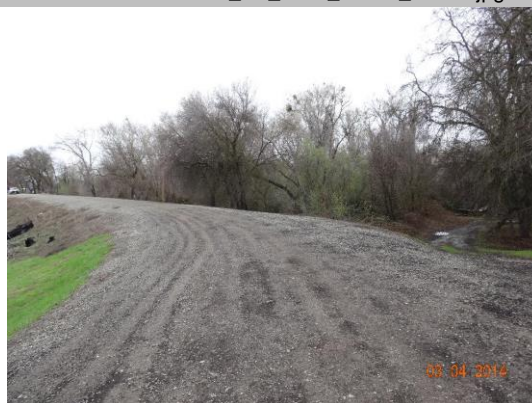
Photo 2 of 3 : UCIP_FA_2018_31632_57903.jpg

Overview of levee crown at crossing.

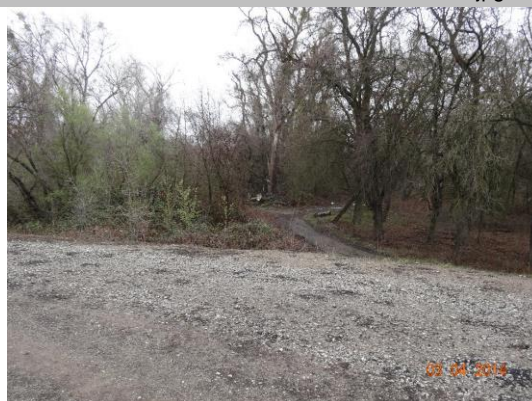
Photo 3 of 3 : UCIP_FA_2018_31632_57904.jpg

View of waterward side.

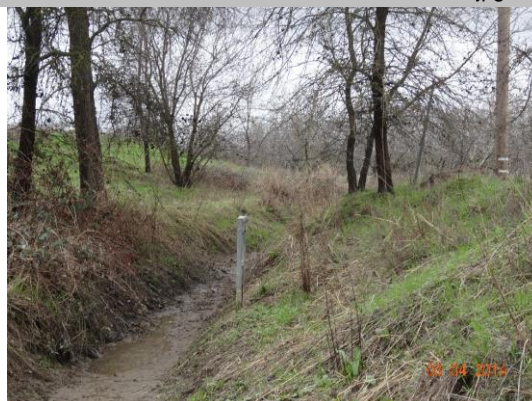
Photo 1 of 3 : UCIP_FA_2018_31915_58270.jpg

Slide gate inside canal.

Comment Code						
Inspector Comment						
FS_ID:31915 DS_ID:19538 EP_NO: N/A Repair Type: Non-Urgent Crossing Status: Indicator Found UCIP Comments: Buried gate valve on landward slope. Crossing appears to be non-functional. Landward pipe section across canal has deteriorated. Will need to contact owner to determine status of crossing. If crossing is not in use owner will need to contact the CVFPB to abandon properly according to Title 23. FIELD_STRUCT_DESC: 20-inch corrugated metal gravity drainage pipe through the levee, at an unknown depth. 20-inch gate valve on the landside (LS) slope. This crossing could be the same record as DS_ID 19524 - unable to confirm. [Additional Reference(s): USACE Sacramento O&M Manual 127, June 1953, (Station 208+15)]. FS Date: 3/4/2014

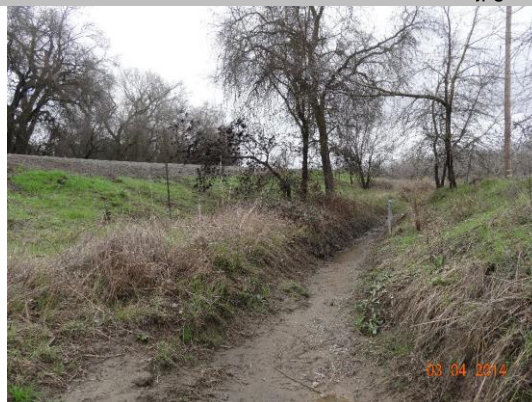
Photo 2 of 3 : UCIP_FA_2018_31915_58269.jpg

View of canal runs parallel on landward toe.

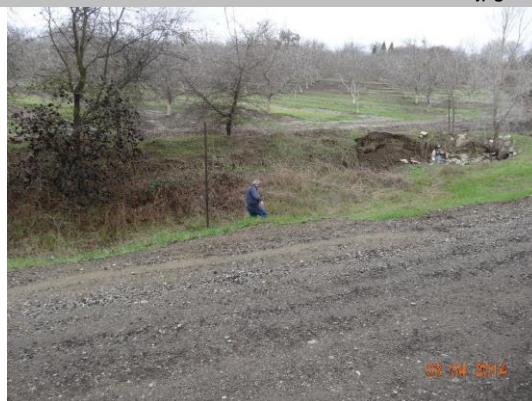
Photo 3 of 3 : UCIP_FA_2018_31915_58272.jpg

View of landward side.

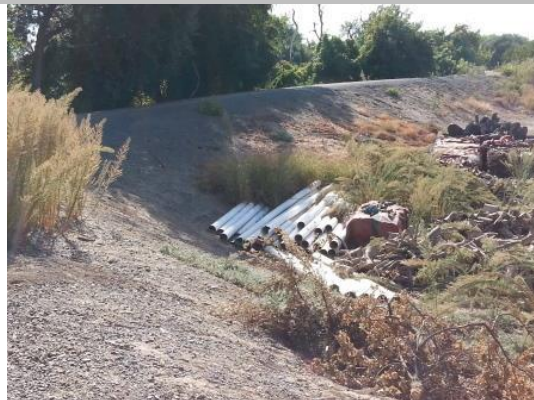
Photo 1 of 2 : FA_2018_NA0022_350_40_20180904_00023.jpg

LM Start	2.18	Rating **	M	Issue No.	40
LM End	2.18	Issue Type +	En	Location *	LS
Category	Earthen Levee			GPS Latitude/Longitude	
				Start	End
Item	Encroachments			38.792499°	38.792499°
				-121.695508°	-121.695508°
DWR ID	DWR_NA0022_01_s_2012_40				
Comment Code					
EQ : Equipment					
Inspector Comment					
Equipment is placed at the toe of the levee.

An updated view of the equipment on landward side. Fall inspection 10/07/2016.

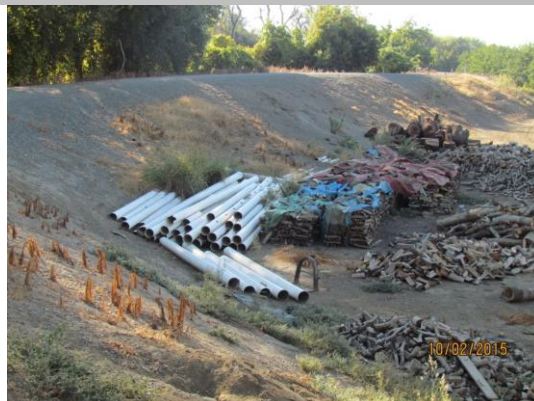
Photo 2 of 2 : FA_2018_NA0022_350_40_20180904_00024.jpg

View of equipment on the landward side of the levee looking downstream. Fall 2015.

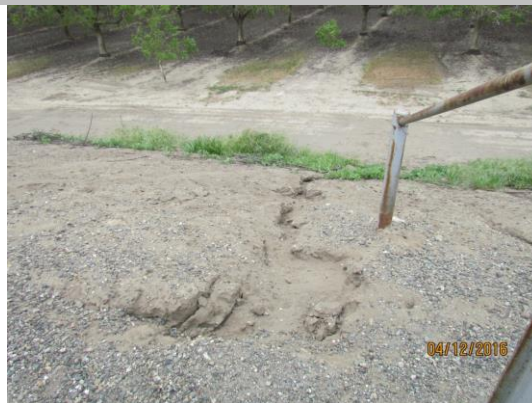
Photo 2 of 2 : FA_2018_NA0022_350_35_20180904_00018.jpg

LM Start	2.24	Rating **	M	Issue No.	35
LM End	2.28	Issue Type +	Ma	Location *	LS
Category	Earthen Levee			GPS Latitude/Longitude	
				Start	End
Item	Erosion / Bank Caving			38.791652 °	38.791172 °
				-121.695403 °	-121.695165 °
DWR ID	DWR_NA0022_01_s_2016_35				
Comment Code					
E2 : Schedule repair of erosion site prior to the next inspection.					
Inspector Comment					
Repair rills on landward side of the levee.

Erosion is on the landward side of the levee. Spring 2016.

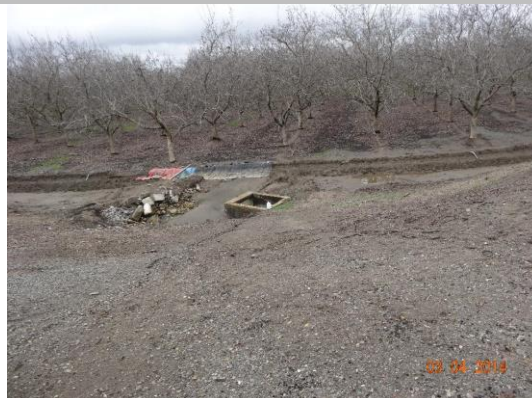
Photo 1 of 3 : UCIP_FA_2018_52726_57915.jpg

Comment Code					
Inspector Comment					
FS_ID:52726 DS_ID:19525 EP_NO: N/A Repair Type: Urgent Crossing Status: Found UCIP Comments: 7/17/2018 Erosion near concrete box on LS did not progress, but still poses a threat to levee integrity. Recommend internal pipe inspection to determine pipe integrity through levee. (O.Yakimov-DWR UCIP)7/13/2016 same as last inspection. Erosion has progressed. Need to coordinate with owner to address erosion on LS toe. (DWR UCIP - omagana)3/04/2014 Surface erosion near concrete box on landward side. Unable to determine if crossing is leaking or if pump is pulling sand from waterward side. Need to contact owner to determine status of crossing and to check integrity of crossing. (DWR UCIP - omagana) FIELD_STRUCT_DESC: 16-inch steel irrigation discharge pipe through the levee, 4 feet below the crown (1955 levee log indicates crossing is 18.9 feet below the crown). Concrete well and pump house on the waterside (WS). Screw gate in pump house. Slant pump mounted on a steel structure on the riverbank. 4-foot by 4-foot concrete discharge box on the landside (LS) toe. Overhead power line and anchor crosses levee. Pole on each shoulder. (Plans for installation of a pump on the bank and to utilize an existing discharge pipe through the levee authorized under Permit No. 5951, 1967 - Elizabeth Huston). [Additional Reference(s): DWR Levee Log, 2005. USACE Sacramento O&M Manual 127, June 1953, (Station 192+60)]. FS Date: 8/6/2018 8:28:18 AM

View of LS toe.

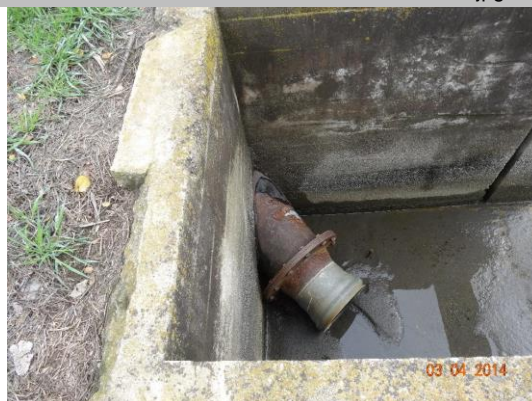
Photo 3 of 3 : UCIP_FA_2018_52726_57913.jpg

Comment Code						
Inspector Comment						
FS_ID:52726 DS_ID:19525 EP_NO: N/A Repair Type: Urgent Crossing Status: Found UCIP Comments: 7/17/2018 Erosion near concrete box on LS did not progress, but still poses a threat to levee integrity. Recommend internal pipe inspection to determine pipe integrity through levee. (O.Yakimov-DWR UCIP)7/13/2016 same as last inspection. Erosion has progressed. Need to coordinate with owner to address erosion on LS toe. (DWR UCIP - omagana)3/04/2014 Surface erosion near concrete box on landward side. Unable to determine if crossing is leaking or if pump is pulling sand from waterward side. Need to contact owner to determine status of crossing and to check integrity of crossing. (DWR UCIP - omagana) FIELD_STRUCT_DESC: 16-inch steel irrigation discharge pipe through the levee, 4 feet below the crown (1955 levee log indicates crossing is 18.9 feet below the crown). Concrete well and pump house on the waterside (WS). Screw gate in pump house. Slant pump mounted on a steel structure on the riverbank. 4-foot by 4-foot concrete discharge box on the landside (LS) toe. Overhead power line and anchor crosses levee. Pole on each shoulder. (Plans for installation of a pump on the bank and to utilize an existing discharge pipe through the levee authorized under Permit No. 5951, 1967 - Elizabeth Huston). [Additional Reference(s): DWR Levee Log, 2005. USACE Sacramento O&M Manual 127, June 1953, (Station 192+60)]. FS Date: 8/6/2018 8:28:18 AM

Outlet located on LS.

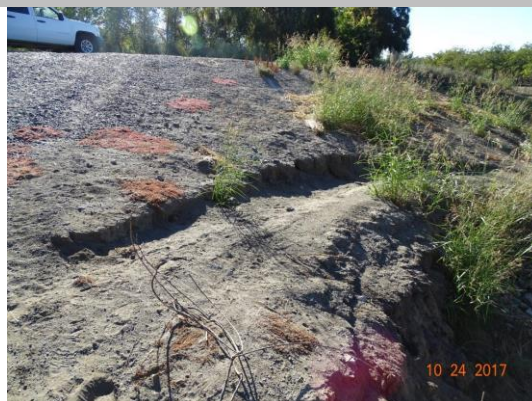
Photo 1 of 4 : FA_2018_NA0022_350_96_20180904_00047.jpg

LM Start	2.35	Rating **	M	Issue No.	96
LM End	2.35	Issue Type +	Ma	Location *	LS
Category	Earthen Levee			GPS Latitude/Longitude	
				Start	End
Item	Erosion / Bank Caving			38.790206 °	38.790206 °
				-121.694534 °	-121.694534 °
DWR ID	DWR_NA0022_01_f_2015_96				
Comment Code					
E1 : Note and monitor erosion site.					
Inspector Comment					
There seems to be an erosion around the concrete box encasing the pipe.

Updated view of erosion on landside slope. Fall 2017.

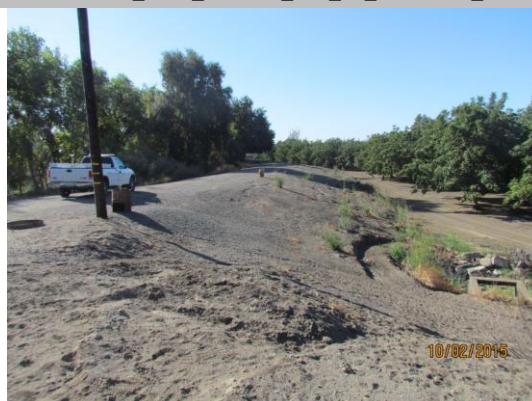
Photo 2 of 4 : FA_2018_NA0022_350_96_20180904_00048.jpg

Perspective view of the erosion around the pipe on the landward side of the levee looking downstream. Fall 2015.

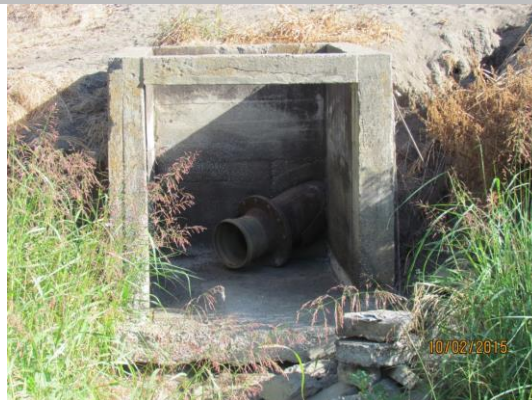
Photo 4 of 4 : FA_2018_NA0022_350_96_20180904_00050.jpg

LM Start	2.35	Rating **	M	Issue No.	96 (cont)	
LM End	2.35	Issue Type +	Ma	Location *	LS	
Category	Earthen Levee			GPS Latitude/Longitude		
				Start		End
Item	Erosion / Bank Caving			38.790206 °	38.790206 °	
				-121.694534 °	-121.694534 °	
DWR ID	DWR_NA0022_01_f_2015_96					
Comment Code						
E1 : Note and monitor erosion site.						
Inspector Comment						
There seems to be an erosion around the concrete box encasing the pipe.

View of the pipe in the concrete box. Fall 2015.

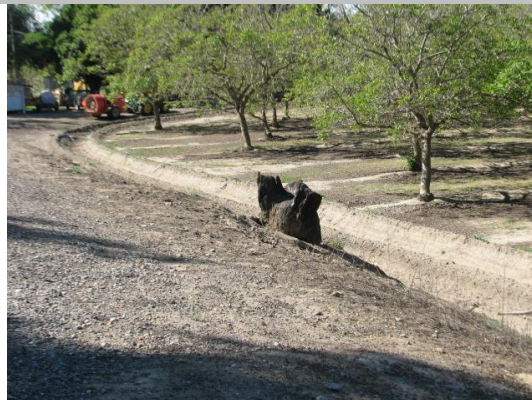
Photo 1 of 1 : FA_2018_NA0022_350_37_20180904_00021.jpg

LM Start	2.52	Rating **	U	Issue No.	37
LM End	2.52	Issue Type +	Ma	Location *	LS
Category	Earthen Levee			GPS Latitude/Longitude	
				Start	End
Item	Trim / Thin Trees			38.787778°	38.787778°
				-121.694296°	-121.694296°
DWR ID	DWR_NA0022_01_s_2014_37				
Comment Code					
T5 : Tree stumps.					
Inspector Comment

Tree stump decomposing and may pose a risk to the levee. Spring 2014

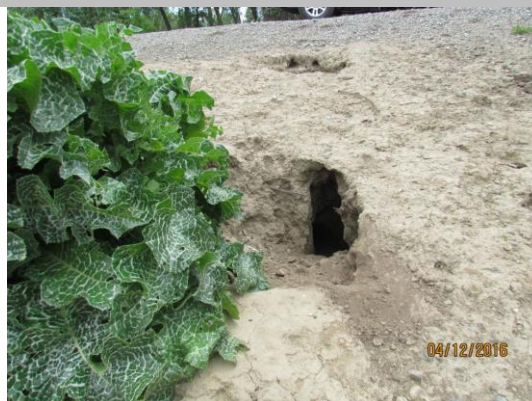
Photo 1 of 2 : FA_2018_NA0022_350_123_20180904_00058.jpg

LM Start	2.52	Rating **	U	Issue No.	123
LM End	2.52	Issue Type +	Ma	Location *	LS
Category	Earthen Levee			GPS Latitude/Longitude	
				Start	End
Item	Animal Control			38.787768 °	38.787768 °
				-121.694295 °	-121.694295 °
DWR ID	DWR_NA0022_01_s_2016_123				
Comment Code					
A3 : No rodents visible, but rodent burrows visible; need to backfill and compact or grout burrows.					
Inspector Comment

View of the rodent hole next to a tree stump on the landward side of the levee. Spring 2016.

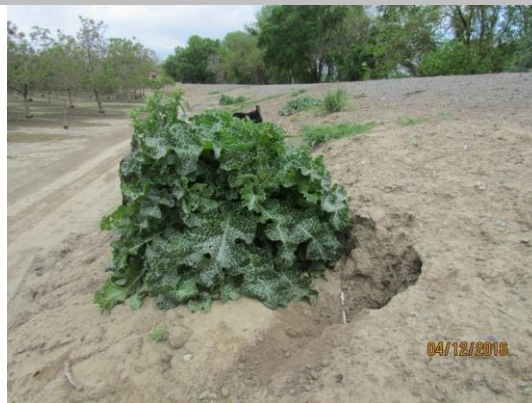
Photo 2 of 2 : FA_2018_NA0022_350_123_20180904_00059.jpg

Perspective view of the rodent hole looking upstream. Spring 2016.

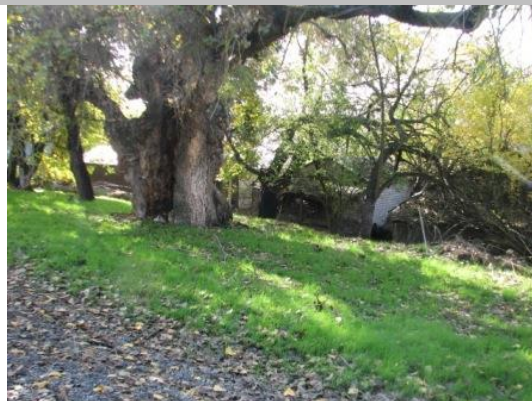
Photo 1 of 2 : FA_2018_NA0022_350_12_20180904_00007.jpg

LM Start	3.06	Rating **	M	Issue No.	12
LM End	3.14	Issue Type +	En	Location *	LS
Category	Earthen Levee			GPS Latitude/Longitude	
				Start	End
Item	Encroachments			38.781828 °	38.780852 °
				-121.689415 °	-121.688887 °
DWR ID	DWR_NA0022_01_f_2017_12				
Comment Code					
BU : Building					
Inspector Comment

Buildings are located at the toe of the levee. Fall 2012

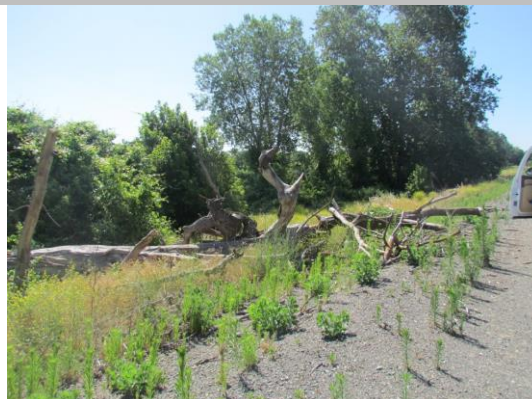
Photo 1 of 2 : FA_2018_NA0022_350_47_20180904_00025.jpg

LM Start	3.14	Rating **	M	Issue No.	47
LM End	3.14	Issue Type +	Ma	Location *	WS
Category	Earthen Levee			GPS Latitude/Longitude	
				Start	End
Item	Encroachments			38.780857 °	38.780857 °
				-121.688921 °	-121.688921 °
DWR ID	DWR_NA0022_01_s_2015_47				
Comment Code					
TR : Tree or limb					
Inspector Comment					
The tree has fallen over from Spring 2014.

View of the fallen tree on the waterward side of the levee looking downstream. Spring 2015.

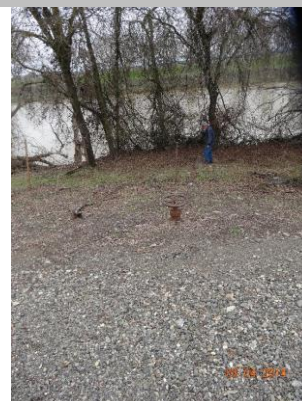
Photo 1 of 3 : UCIP_FA_2018_39858_71841.jpg

Comment Code					
Inspector Comment					
FS_ID:39858 DS_ID:19526 EP_NO: 3205 Repair Type: Non-Urgent Crossing Status: Found UCIP Comments: Need to contact owner to determine status of crossing. If crossing is no longer used need to coordinate with CVFPB for proper abandonment. FIELD_STRUCT_DESC: 12-inch coated steel irrigation discharge pipe through the levee, 4 feet below the crown. Metal cutoff wall. Pump on the waterside (WS). Gate valve on the WS slope. Siphon breaker in an 18-inch concrete riser on the landside (LS) slope. 36-inch concrete standpipe at the LS toe. (Previous pipe referenced as USACE O&M irrigation pipe, Station 144+80, was removed and a 12-inch pipe was reinstalled under Permit No. 3205, 1959 - Mary A. Richardson). [Additional Reference(s): DWR Levee Log, 2005. USACE Sacramento O&M Manual 127, June 1953, (Station 144+80)]. FS Date: 3/4/2014

View of waterward side.

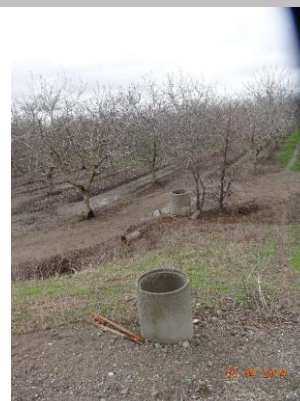
Photo 1 of 3 : UCIP_FA_2018_31916_58275.jpg

Comment Code					
Inspector Comment					
FS_ID:31916 DS_ID:19545 EP_NO: N/A Repair Type: Non-Urgent Crossing Status: Indicator Found UCIP Comments: Need to contact owner--Crossing appears to be abandoned. If crossing is no longer in use, crossing need to be abandoned properly per Title 23. FIELD_STRUCT_DESC: *REMOVED* 12-inch steel irrigation discharge pipe through the levee, at an unknown depth. Pump on the waterside (WS). Concrete standpipe on the landside (LS). (Previous pipe referenced as USACE O&M irrigation pipe, Station 144+80, was removed and a 12-inch pipe was reinstalled under Permit No. 3205, 1959 - Mary A. Richardson). [Additional Reference(s): USACE Sacramento O&M Manual 127, June 1953, (Station 144+80)]. FS Date: 3/4/2014

View of landward side.

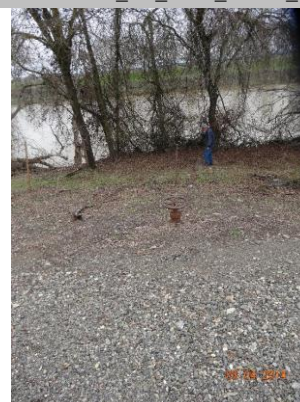
Photo 2 of 3 : UCIP_FA_2018_31916_58274.jpg

View of waterward side.

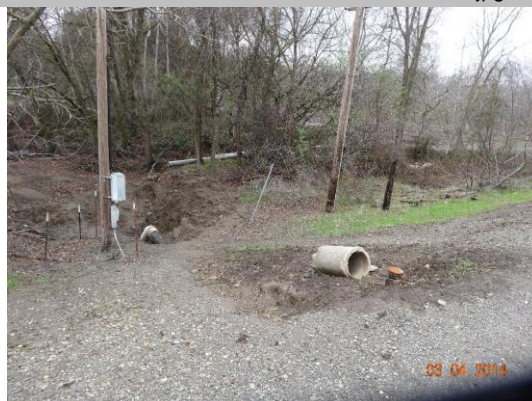
Photo 1 of 3 : UCIP_FA_2018_52727_58279.jpg

Comment Code					
Inspector Comment					
FS_ID:52727 DS_ID:19527 EP_NO: 3729 Repair Type: Non-Urgent Crossing Status: Found UCIP Comments: 07/17/2018 Section of WS levee slope that was disturbed during flow meter installation was backfilled but not compacted properly. Due to this, crossing downgraded to "Non-Urgent". Water pump was running during inspection, no leaks detected. (O.Yakimov-DWR UCIP)10/24/2017 Received updated photos of site from DWR levee inspector, Z. Jojola. Photos show levee slope has been disturbed where the flow meter is attached to pipe on the WS and section of the levee has not been backfill per Title 23 requirements. Recommend contacting the owner and coordinating with LMA about the issue. Crossing has been upgraded from Non-Urgent to Urgent due to disturbance of levee section. (DWR UCIP - O. Magana)03/04/2014 Crossing has been modified. Need to contact owner to determine additional information pertaining to the modifications. (DWR UCIP - O. Magana) FIELD_STRUCT_DESC: 10-inch irrigation discharge pipe of an unknown material through the levee, 3 feet below the crown. Metal cutoff wall. 1.5-inch electrical conduit through the levee, 1 foot below the crown. Service pole and meter at the landside (LS) toe. Pump and gate valve on the riverbank with an access ramp. Siphon breaker in a 12-inch concrete riser on the LS shoulder. (Plans for installation of a 10-inch centrifugal pump on the bank with a discharge pipe through the levee authorized under Permit No. 3729, 1961 - Clayton Russell). [Additional Reference(s): DWR Levee Log, 2005]. FS Date: 7/17/2018

View of landward side, photo 1 of 2.

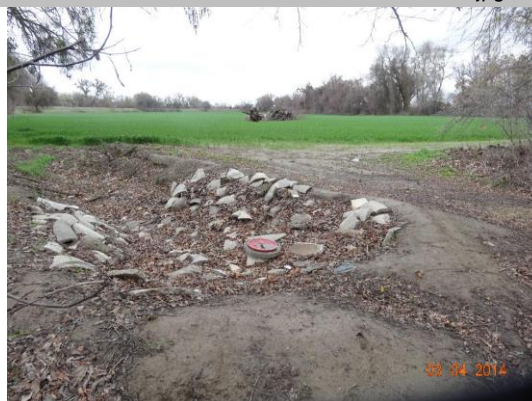
Photo 2 of 3 : UCIP_FA_2018_52727_58282.jpg

Comment Code						
Inspector Comment						
FS_ID:52727						
DS_ID:19527						
EP_NO: 3729						
Repair Type: Non-Urgent						
Crossing Status: Found						
UCIP Comments: 07/17/2018 Section of WS levee slope that was disturbed during flow meter installation was backfilled but not compacted properly. Due to this, crossing downgraded to "Non-Urgent". Water pump was running during inspection, no leaks detected. (O.Yakimov-DWR UCIP)10/24/2017 Received updated photos of site from DWR levee inspector, Z. Jojola. Photos show levee slope has been disturbed where the flow meter is attached to pipe on the WS and section of the levee has not been backfill per Title 23 requirements. Recommend contacting the owner and coordinating with LMA about the issue. Crossing has been upgraded from Non-Urgent to Urgent due to disturbance of levee section. (DWR UCIP - O. Magana)03/04/2014 Crossing has been modified. Need to contact owner to determine additional information pertaining to the modifications. (DWR UCIP - O. Magana)

View of landward side, photo 2 of 2.

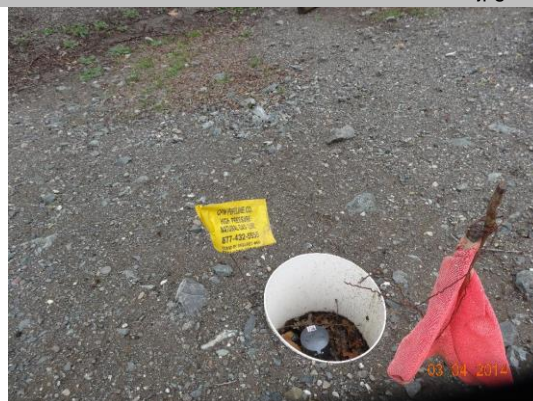
Photo 3 of 3 : UCIP_FA_2018_52727_58281.jpg

Comment Code						
Inspector Comment						
FS_ID:52727 DS_ID:19527 EP_NO: 3729 Repair Type: Non-Urgent Crossing Status: Found UCIP Comments: 07/17/2018 Section of WS levee slope that was disturbed during flow meter installation was backfilled but not compacted properly. Due to this, crossing downgraded to "Non-Urgent". Water pump was running during inspection, no leaks detected. (O.Yakimov-DWR UCIP)10/24/2017 Received updated photos of site from DWR levee inspector, Z. Jojola. Photos show levee slope has been disturbed where the flow meter is attached to pipe on the WS and section of the levee has not been backfill per Title 23 requirements. Recommend contacting the owner and coordinating with LMA about the issue. Crossing has been upgraded from Non-Urgent to Urgent due to disturbance of levee section. (DWR UCIP - O. Magana)03/04/2014 Crossing has been modified. Need to contact owner to determine additional information pertaining to the modifications. (DWR UCIP - O. Magana) FIELD_STRUCT_DESC: 10-inch irrigation discharge pipe of an unknown material through the levee, 3 feet below the crown. Metal cutoff wall. 1.5-inch electrical conduit through the levee, 1 foot below the crown. Service pole and meter at the landside (LS) toe. Pump and gate valve on the riverbank with an access ramp. Siphon breaker in a 12-inch concrete riser on the LS shoulder. (Plans for installation of a 10-inch centrifugal pump on the bank with a discharge pipe through the levee authorized under Permit No. 3729, 1961 - Clayton Russell). [Additional Reference(s): DWR Levee Log, 2005]. FS Date: 7/17/2018

Flow meter located on waterward shoulder.

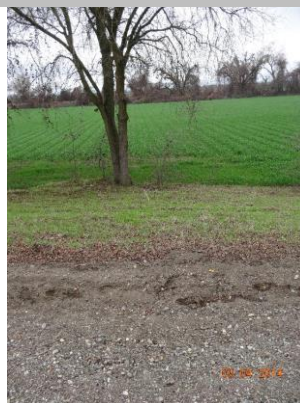
Photo 1 of 3 : UCIP_FA_2018_38996_69568.jpg

Comment Code						
Inspector Comment						
FS_ID:38996						
DS_ID:19528						
EP_NO: 3722						
Repair Type: Non-Urgent						
Crossing Status: Found						
UCIP Comments: Pipe visible only on waterward side--Pipe needs to be properly abandoned per Title 23. Need to contact owner to determine status of crossing.						
FIELD_STRUCT_DESC: *ABANDONED* 10-inch steel irrigation discharge pipe through the levee, 3 feet below the crown. Metal cutoff walls at centerline of levee. 1.5-inch electrical conduit through the levee, 1 foot below the crown. Pump and gate valve on the riverbank. Siphon breaker in a 12-inch concrete riser on the landside (LS) shoulder. Pipe connects to an existing 24-inch concrete standpipe at the LS toe. (Plans for construction of a pumping plant on the bank authorized under Permit No. 3722, 1961 - Glen L. and Duane P. Traganza). No standpipe found at the LS toe. In the 1955 levee log, the crossing was referenced as a 10-inch pipe, 5.3 feet below the crown, at HLM 3.60. [Additional Reference(s): DWR Levee Log, 2005].

View of landward side.

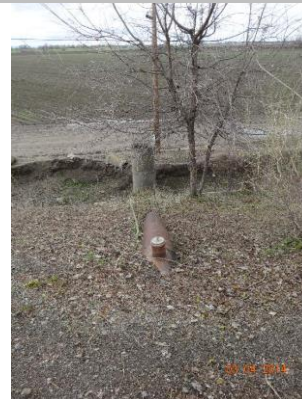
Photo 1 of 3 : UCIP_FA_2018_38999_57948.jpg

Comment Code					
Inspector Comment					
FS_ID:38999 DS_ID:19529 EP_NO: 4570 Repair Type: Non-Urgent Crossing Status: Found UCIP Comments: Need to contact owner to determine status of crossing. CMP riser damage on waterward slope. FIELD_STRUCT_DESC: 16-inch steel irrigation discharge pipe through the levee, 5 feet below the crown. Metal plate welded on the waterside (WS) end. Pump, 1.5-inch electrical conduit, and gate valve in a concrete U-shaped headwall are located on the riverbank. (Plans to replace existing pump on the riverbank authorized under Permit 7618-A, 1974 - Wallace Construction Company, Inc., care of Laugenour and Meikle). Pipe extends from the pump to a concrete standpipe on the landside (LS). Pipe exposed on the LS slope. Water meter in a 36-inch corrugated metal pipe (CMP) riser on the WS slope. Siphon breaker in a 7-inch metal riser on the LS shoulder. 30-inch concrete riser at the LS toe. Metal cutoff wall installed. (Plans for construction of a pumping plant with a discharge pipe through the levee authorized under Permit No. 4570, 1964 - England Brothers). [Additional Reference(s): DWR Levee Log, 2005]. FS Date: 3/4/2014

View of landward side.

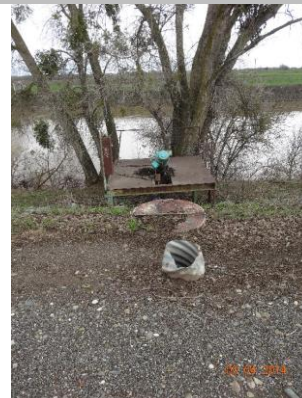
Photo 2 of 3 : UCIP_FA_2018_38999_57947.jpg

View of waterward side.

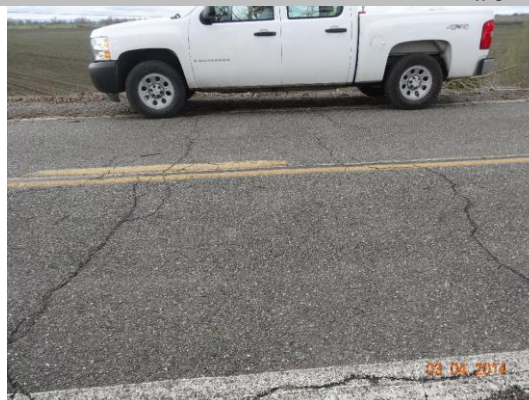
Photo 3 of 3 : UCIP_FA_2018_38999_57946.jpg

View of levee crown at crossing.

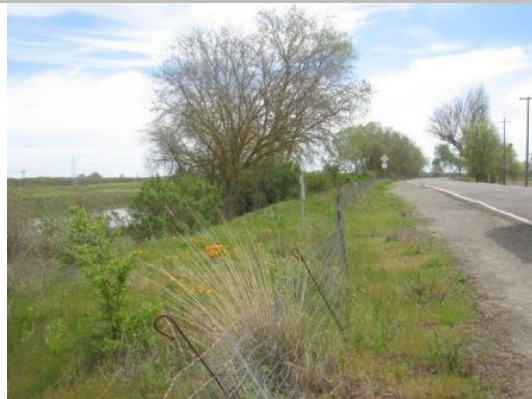
Photo 1 of 2 : FA_2018_NA0022_350_36_20180904_00019.jpg

LM Start	4.25	Rating **	A/W	Issue No.	36
LM End	4.49	Issue Type +	Ma	Location *	WS
Category	Earthen Levee			GPS Latitude/Longitude	
				Start	End
Item	Vegetation			38.767125 °	38.764582 °
				-121.693267 °	-121.690285 °
DWR ID	DWR_NA0022_01_f_2017_36				
Comment Code					
V8 : Environmental Requirements.					
Inspector Comment

Another view of the site.

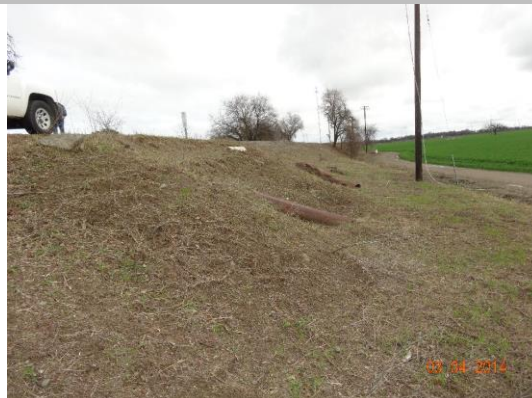
Photo 1 of 3 : UCIP_FA_2018_31986_58442.jpg

Comment Code					
Inspector Comment					
FS_ID:31986 DS_ID:19530 EP_NO: 9409 Repair Type: Non-Urgent Crossing Status: Found UCIP Comments: Pump station not found. Crossing appears to be abandon. Need to contact owner to determine status. Repair site on waterward side--waterward slope revegetated. FIELD_STRUCT_DESC: 16-inch steel irrigation discharge pipe through the levee, 6.4 feet below the crown. Pump and control valve on the riverbank. Ramp on the landside (LS) slope. (Retention of a 16-inch pipe through the levee and a pump on the riverbank authorized under Automatic Board Order (ABO) issued as Permit No. 9409, 1974 - Clayton Russell). [Additional Reference(s): DWR Levee Log, 2005]. FS Date: 3/4/2014

View of landward side.

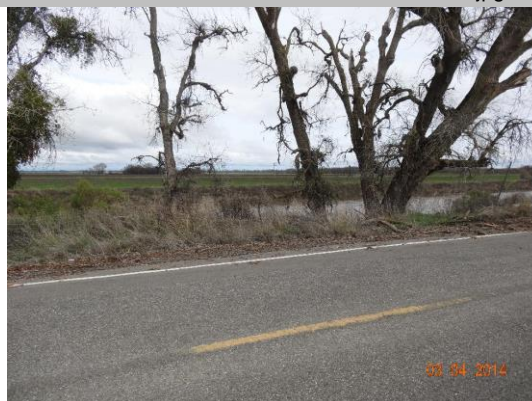
Photo 3 of 3 : UCIP_FA_2018_31986_58441.jpg

Comment Code						
Inspector Comment						
FS_ID:31986 DS_ID:19530 EP_NO: 9409 Repair Type: Non-Urgent Crossing Status: Found UCIP Comments: Pump station not found. Crossing appears to be abandon. Need to contact owner to determine status. Repair site on waterward side--waterward slope revegetated. FIELD_STRUCT_DESC: 16-inch steel irrigation discharge pipe through the levee, 6.4 feet below the crown. Pump and control valve on the riverbank. Ramp on the landside (LS) slope. (Retention of a 16-inch pipe through the levee and a pump on the riverbank authorized under Automatic Board Order (ABO) issued as Permit No. 9409, 1974 - Clayton Russell). [Additional Reference(s): DWR Levee Log, 2005]. FS Date: 3/4/2014

View of waterward side.

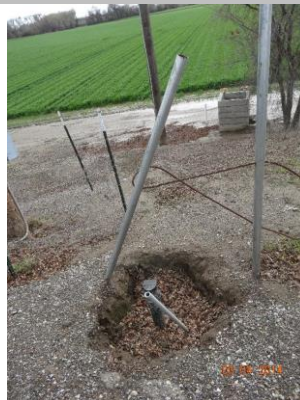
Photo 1 of 3 : UCIP_FA_2018_52728_69573.jpg

UCIP Comments: 7/17/2018 Subsidence around siphon breaker on LS is present, although didn't increase in diameter. Water pump was running during site visit, small leak from pipe connection was observed on LS. (O.Yakimov-DWR UCIP)7/13/2016 same as last inspection - hole is still present near siphon breaker. Dense vegetation present and limits the inspector's visibility to identify signs of pipe failure (leaks) along the WS and LS slopes. Recommend removing vegetation along pipe alignment to conduct proper inspection of structure and appurtenances. (DWR UCIP - omagana)3/04/2014 Subsidence visible where siphon breaker is located on landward side. Unable to determine if subsidence is due to poor compaction or leak at siphon breaker. Need to contact owner to address issue. (DWR UCIP - omagana)

LM Start	4.52	Rating **	U	Issue No.	416 (cont)
LM End	4.52	Issue Type +	En	Location *

View of LS--subsidence near levee crown.

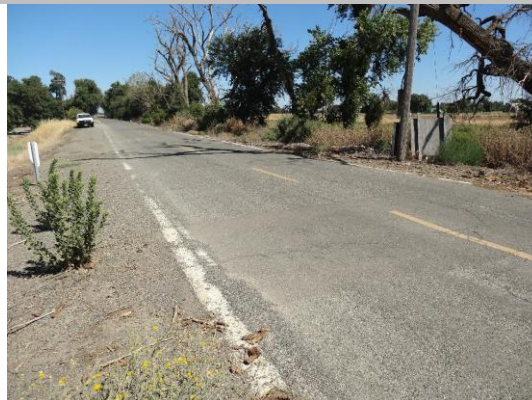
Photo 3 of 3 : UCIP_FA_2018_52728_75759.jpg

Comment Code						
Inspector Comment						
FS_ID:52728 DS_ID:19537 EP_NO: 18298 Repair Type: Urgent Crossing Status: Found UCIP Comments: 7/17/2018 Subsidence around siphon breaker on LS is present, although didn't increase in diameter. Water pump was running during site visit, small leak from pipe connection was observed on LS. (O.Yakimov-DWR UCIP)7/13/2016 same as last inspection - hole is still present near siphon breaker. Dense vegetation present and limits the inspector's visibility to identify signs of pipe failure (leaks) along the WS and LS slopes. Recommend removing vegetation along pipe alignment to conduct proper inspection of structure and appurtenances. (DWR UCIP - omagana)3/04/2014 Subsidence visible where siphon breaker is located on landward side. Unable to determine if subsidence is due to poor compaction or leak at siphon breaker. Need to contact owner to address issue. (DWR UCIP - omagana) FIELD_STRUCT_DESC: 14-inch coated steel water pipe through the levee, 2 feet below the crown. Pump platform is supported by 6 pilings on the waterside (WS) slope. Siphon breaker and air release valve on the landside (LS) shoulder. Concrete distribution box on the LS toe. Rock riprap along the WS slope. (Permit No. 18298, 2007 - Heidrick, [permit not in database]). FS Date: 7/17/2018 11:31:53 AM

Overview of pipe crossing looking upstream.

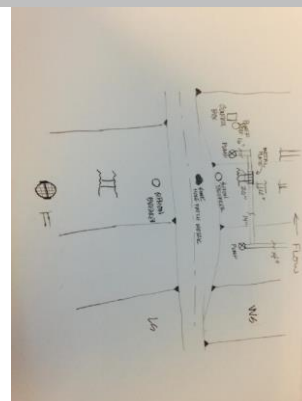
Photo 1 of 3 : UCIP_FA_2018_52729_58451.jpg

FS_ID:52729
DS_ID:19531
EP_NO: 9408
Repair Type: Urgent
Crossing Status: Found
UCIP Comments: 07/17/2018 No change from previous inspection. Patch repair of pavement on levee crown is in the same condition. Good candidate for internal inspection. (O.Yakimov-DWR UCIP)10/24/2017 Received updated photos from DWR levee inspector, Z. Jojola, and the photos show some depression along LS slope. Road patch repair is still visible on levee road, recommend an internal integrity inspection of pipe to determine the condition through the levee and slopes. (DWR UCIP - O. Magana) 07/13/2016 Same as last inspection. Sink hole repair visible on levee road. Recommend contacting owner to determine if an internal integrity inspection of the pipe was completed to confirm sink hole was not the cause of the damage to road. If no internal integrity inspection was completed during road repair, recommend an internal integrity inspection be completed at this location based on the sink hole that developed along pipe alignment and based on age of pipe. (DWR UCIP - omagana)03/04/2014 Signs of sink hole repair on levee crown. Owner will need to contact CVFPB to address sink hole repair. (DWR UCIP - omagana)

Plan view of crossing and appurtenances at CLM 4.692.

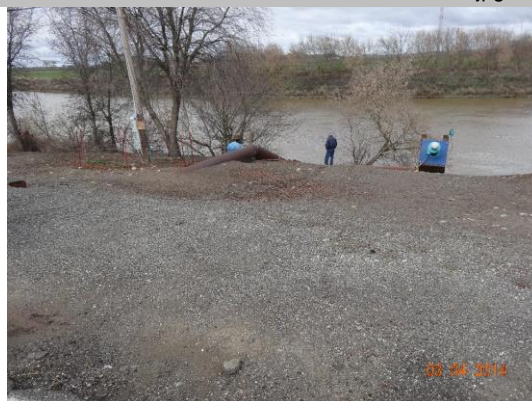
Photo 2 of 3 : UCIP_FA_2018_52729_58455.jpg

Patch repair of pavement on levee crown is in the same condition.

slope. Road patch repair is still visible on levee road, recommend an

as last inspection. Sink hole repair visible on levee road. Recommend

View of WS.

internal integrity inspection of pipe to determine the condition through

road repair, recommend an internal integrity inspection be completed at

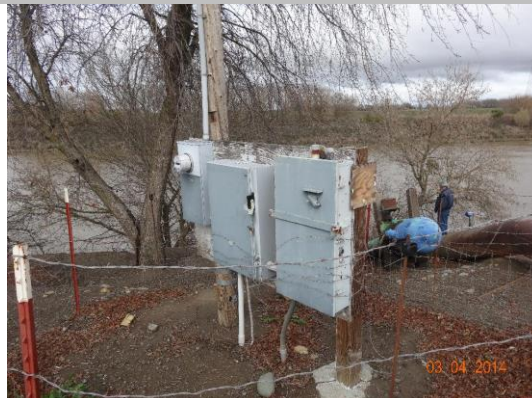
Photo 3 of 3 : UCIP_FA_2018_52729_58459.jpg

Patch repair of pavement on levee crown is in the same condition.

slope. Road patch repair is still visible on levee road, recommend an

as last inspection. Sink hole repair visible on levee road. Recommend

Power pole, meter box, & pump control panels located on WS.

internal integrity inspection of pipe to determine the condition through

road repair, recommend an internal integrity inspection be completed at

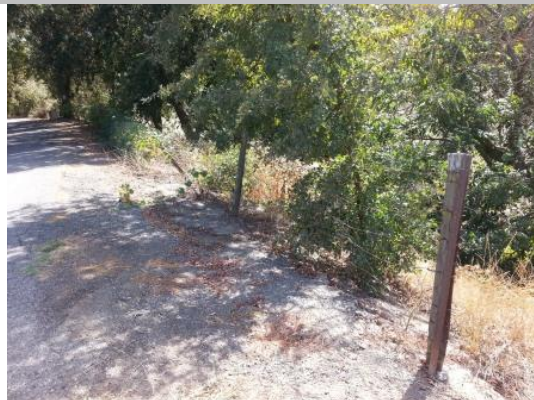
Photo 1 of 1 : FA_2018_NA0022_350_144_20180904_00061.jpg

LM Start	5.28	Rating **	M	Issue No.	144
LM End	5.46	Issue Type +	En	Location *	LS
Category	Earthen Levee			GPS Latitude/Longitude	
				Start	End
Item	Encroachments			38.760047 °	38.759687 °
				-121.677828 °	-121.674620 °
DWR ID	DWR_NA0022_01_f_2016_144				
Comment Code					
FE : Fence					
Inspector Comment

Fence on LS slope near levee crown. Fall inspection 10/07/2016.

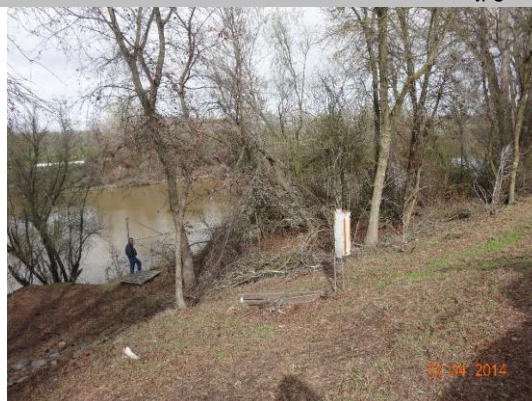
Photo 1 of 3 : UCIP_FA_2018_31927_58332.jpg

Comment Code					
Inspector Comment					
FS_ID:31927 DS_ID:19532 EP_NO: 3811 Repair Type: Non-Urgent Crossing Status: Found UCIP Comments: Unable to confirm is crossing is still in use. Need to contact owner to determine status of crossing. FIELD_STRUCT_DESC: 10-inch steel irrigation discharge pipe through the levee, 3.6 feet below the crown. Pump at the waterside (WS) toe on the riverbank. Standard cutoff wall around the pipe at the center of the levee. Standpipe at the landside (LS) toe. Siphon breaker on the LS shoulder. This crossing replaces the previous USACE O&M irrigation pipe referenced at Station 27+49. (Plans to replace a pump, suction pipe, and discharge pipe of an existing pump on the bank authorized under Permit No. 3811, 1962 - Gus Inglin, care of E. E. Luhdorff Company). [Additional Reference(s): DWR Levee Log, 2005. USACE Sacramento O&M Manual 127, June 1953, (Station 27+49)]. FS Date: 3/4/2014

View of waterward side.
